Manhole Inspection Summary

Manhole # S61G__016MH

Insp Date: **3/28/08 12:55 PM**

Location Address: **Mason Lord Dr.**

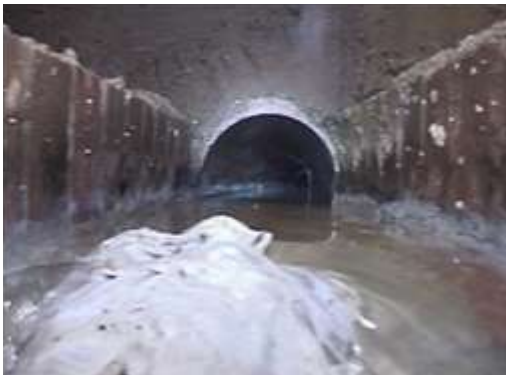
Defect 4

Condition: ☐ Sound ☐ Cracked ☐ Root Intrusion ☐ Deteriorated ☐ Leaks ☒ **Debris**

debris in channel

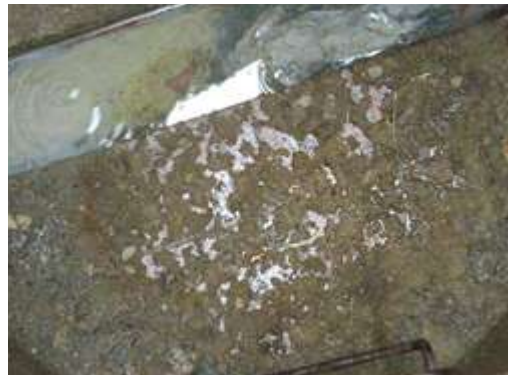
Defect 3

debris on bench

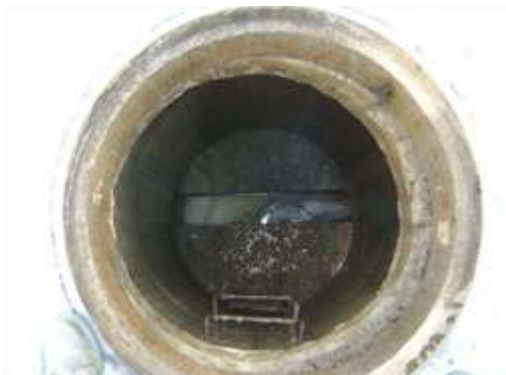
Defect 5

Frame Offset: **2** (in.) Condition: ☒ Sound ☐ Cracked ☐ Leaks

frame offset defect

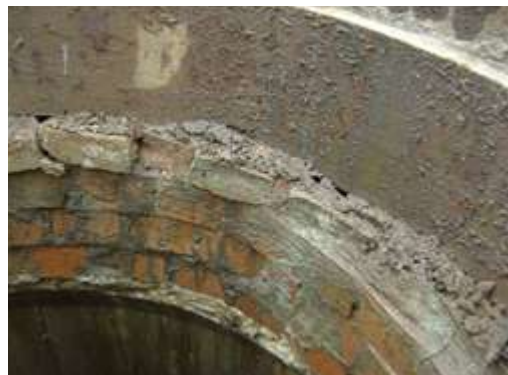
Defect 1

Condition: ☐ Sound ☐ Cracked ☐ Root Intrusion ☒ **Loose Brick** ☒ **Deteriorated**

Infiltration: ☐ None ☒ **Joint** ☐ Cracks ☒ **Mortar** ☐ Roots ☐ Wall

loose bricks and mortar at frame adjustment

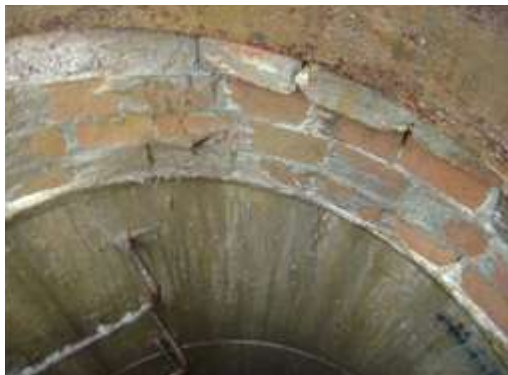
Defect 2

Infiltration: ☐ None ☒ **Joint** ☐ Cracks ☐ Mortar ☐ Roots ☐ Wall

infiltration on barrel wall

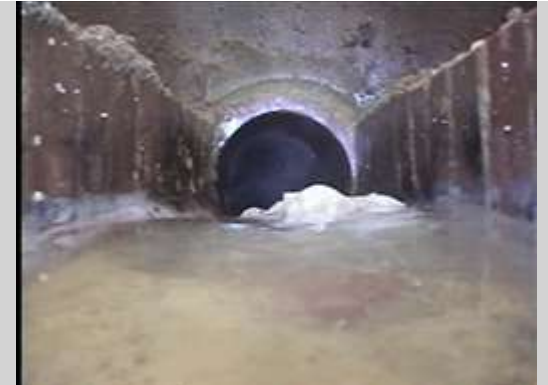
12 O'Clock Outflow

8 in. Circular Gravity Sewer
Pipe Out @ 12 O'Clock

Pipe Height: **8.4** (in.) Rod and Bar (Angled)
Pipe Material: **Clay** ☐ Pipe Lined
Invert Depth: **9.21** (ft.) Flow Characteristics: **Slow**
Deposits: ☒ None ☐ Mud ☐ Sludge ☐ Debris ☐ Grease
Silt Depth: (in.) Deposits Extent:
Infiltration: **None** Pipe Seal Cond: **Sound**

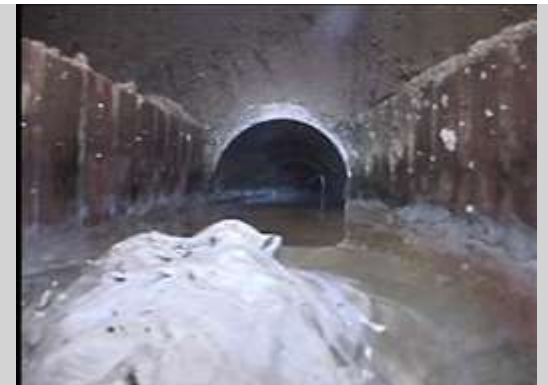
6 O'Clock Inflow

8 in. Circular Gravity Sewer
Pipe In @ 6 O'Clock

Pipe Height: **8.4** (in.) Rod and Bar (Angled)
Pipe Material: **Clay** ☐ Pipe Lined
Invert Depth: **9.17** (ft.) Flow Characteristics: **Fast**
Deposits: ☒ None ☐ Mud ☐ Sludge ☐ Debris ☐ Grease
Silt Depth: (in.) Deposits Extent:
Infiltration: **None** Pipe Seal Cond: **Sound**
